Pavement Condition Report

Stephen Municipal Airport (D41)

December 2016

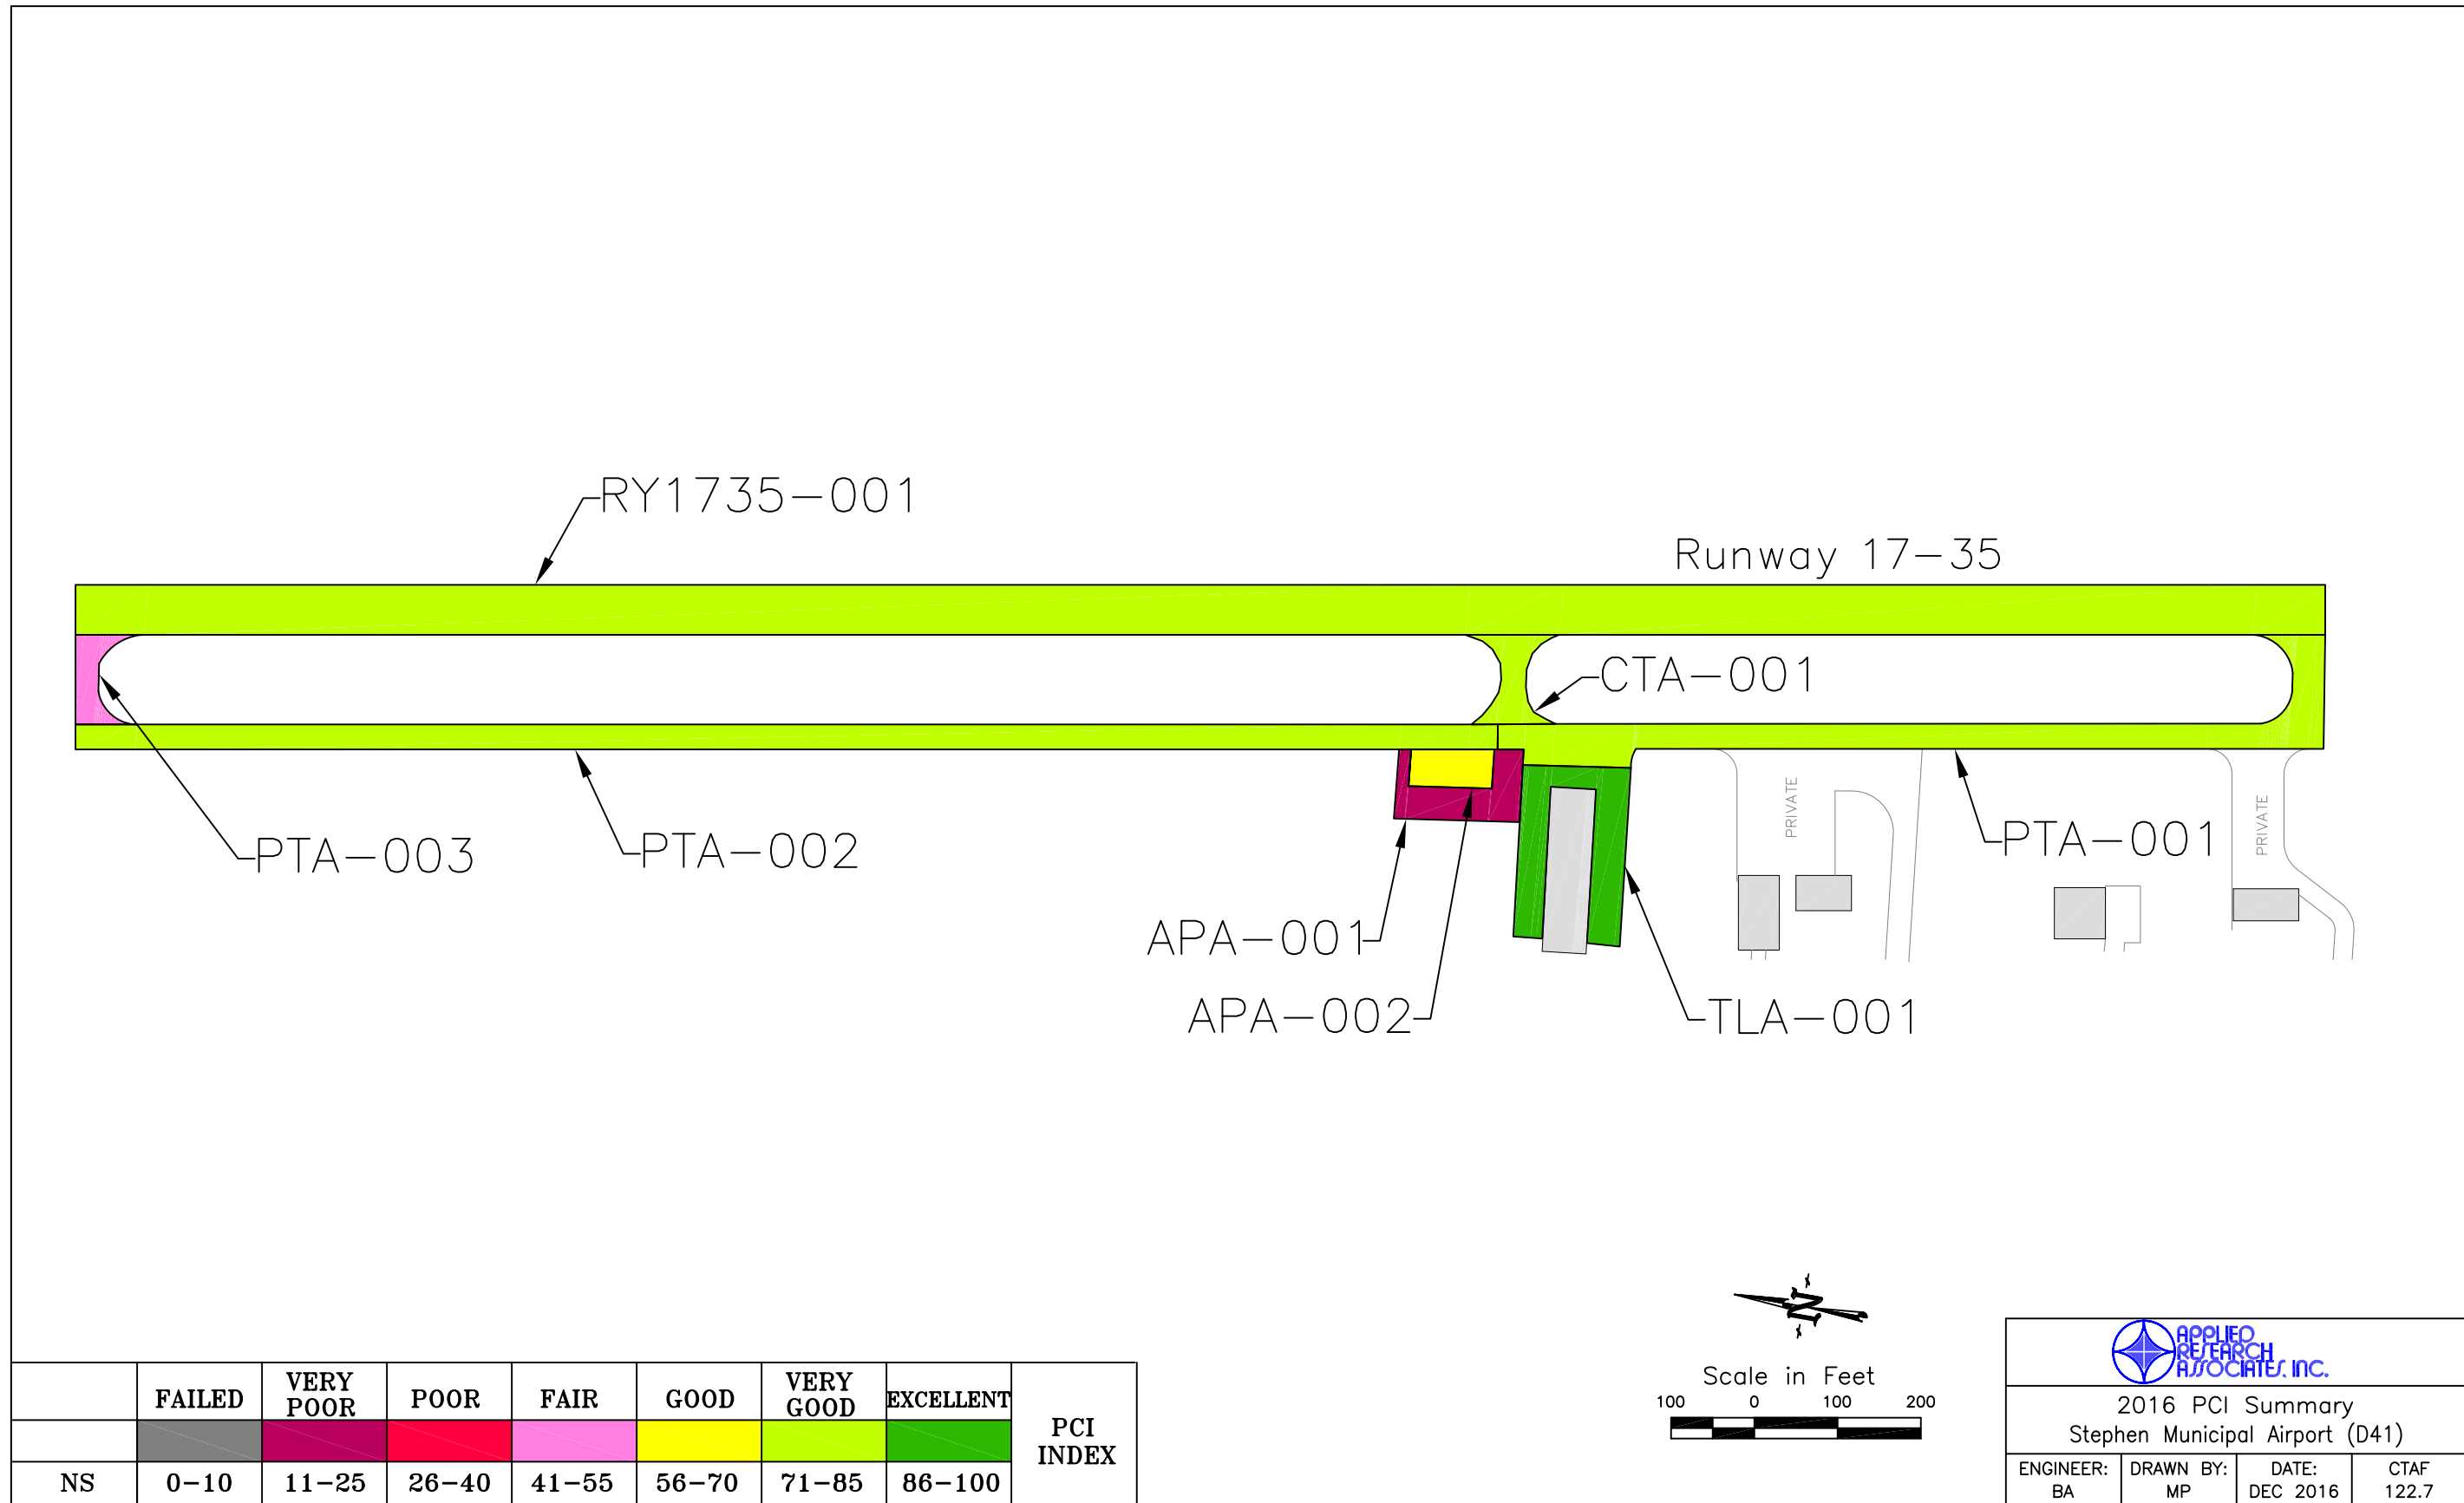
Figure 4. 2016 Pavement Condition Index Rating at Stephen Municipal Airport (D41).

Branch ID	Section ID	Surface type ¹	Section area (SF)	LCD ²	2013 PCI	2016 PCI	Drop in PCI/Yr ³	% Deduct due to		Distress types
								Load ⁴	Climate ⁵	
APA	001	AC	8,500	1973	25	23	2	22	72	Alligator Crack, Depression, L&T Crack, Weathering
APA	002	AAC	5,000	2004	68	63	3	18	82	L&T Crack, Rutting
CTA	001	AC	5,400	1998	81	71	2	-	100	L&T Crack
PTA	001	AC	36,850	1998	84	76	1	-	100	L&T Crack
PTA	002	AC	51,150	2004	84	78	2	-	94	L&T Crack, Swell
PTA	003	AC	4,125	2004	63	52	4	35	33	Alligator Crack, L&T Crack, Swell
RY1735	001	AC	162,000	1998	81	72	2	-	100	L&T Crack
TLA	001	AC	18,100	2014	14	100	-	-	-	-

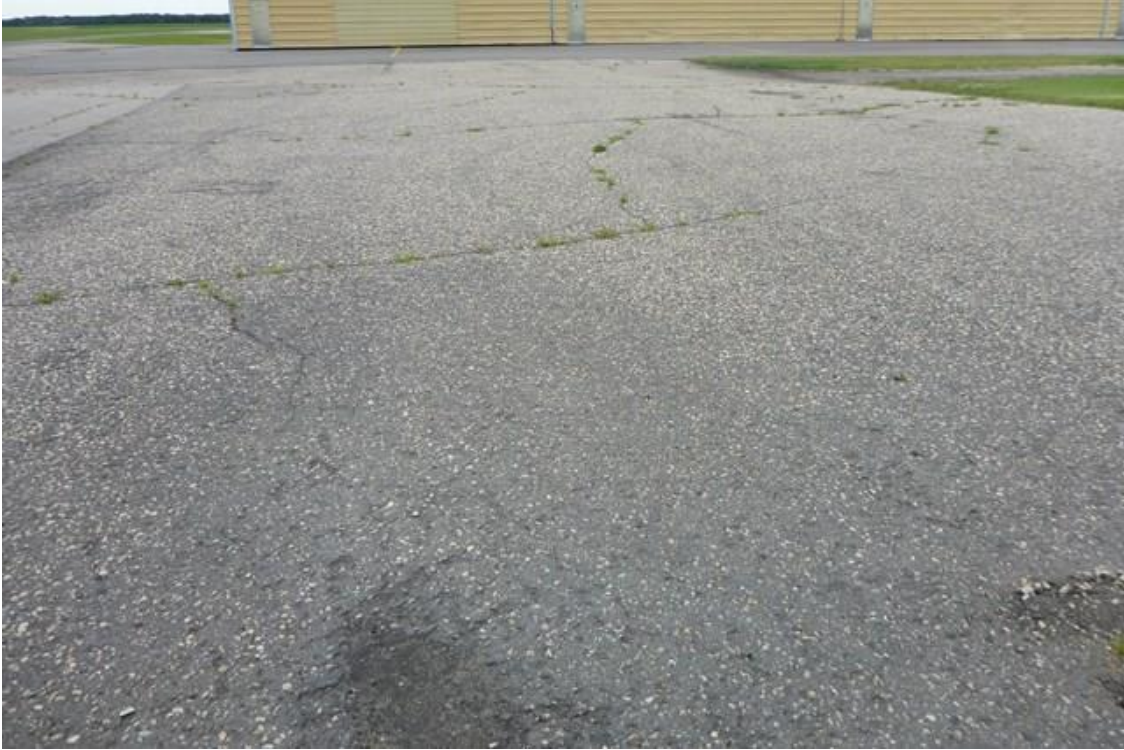
D41 APA 001 (PCI = 23)

Last Insp. Date: 7/16/2016 **TotalSamples:** 3 **Surveyed:** 1
Conditions: PCI: 23
Inspection Comments:

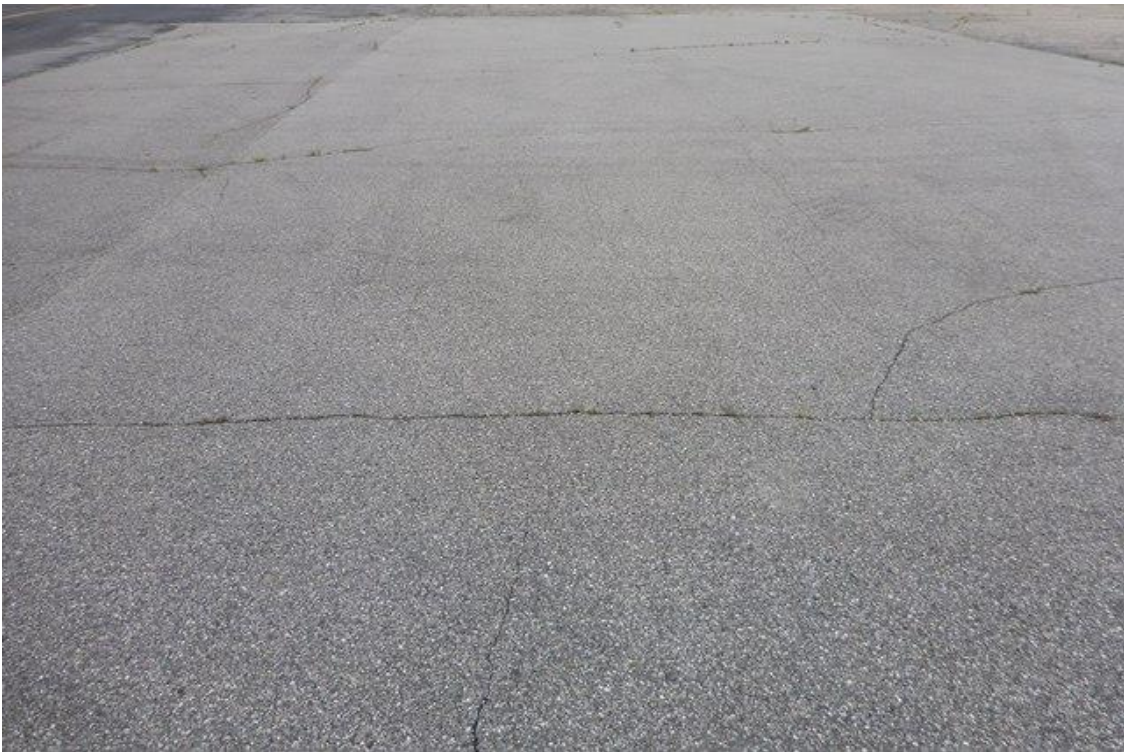
D41 APA 002 (PCI = 63)

Conditions: PCI: 63

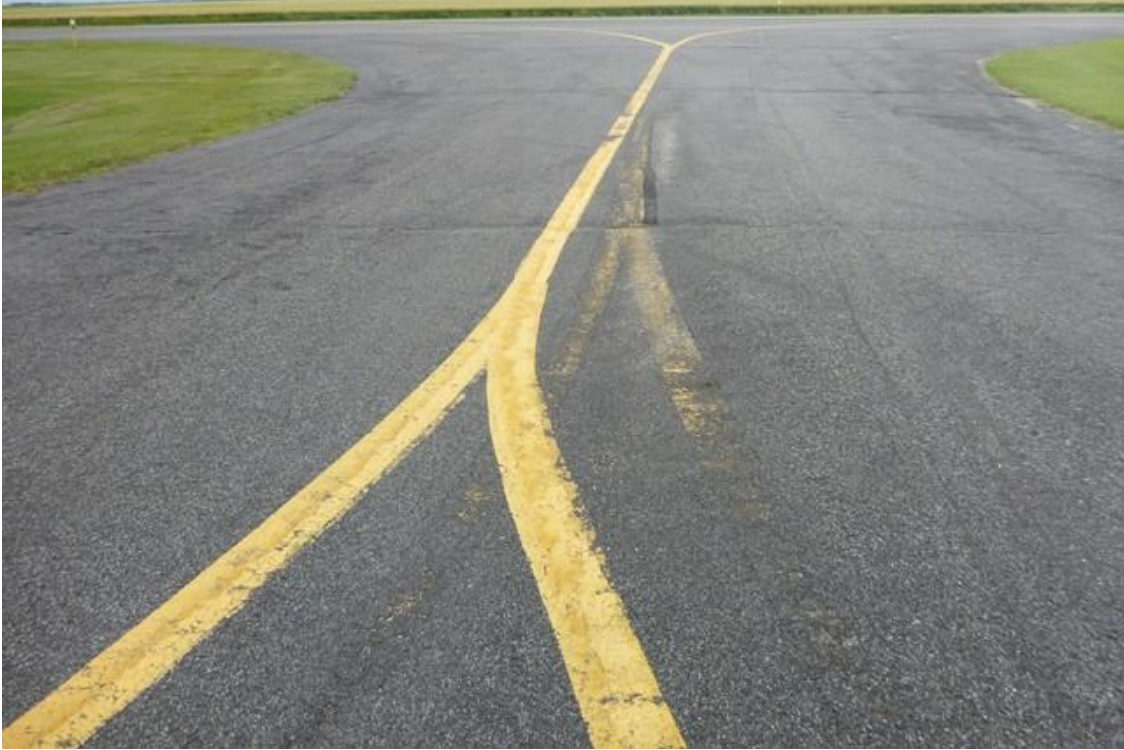
D41 CTA 001 (PCI = 71)

Conditions: PCI: 71

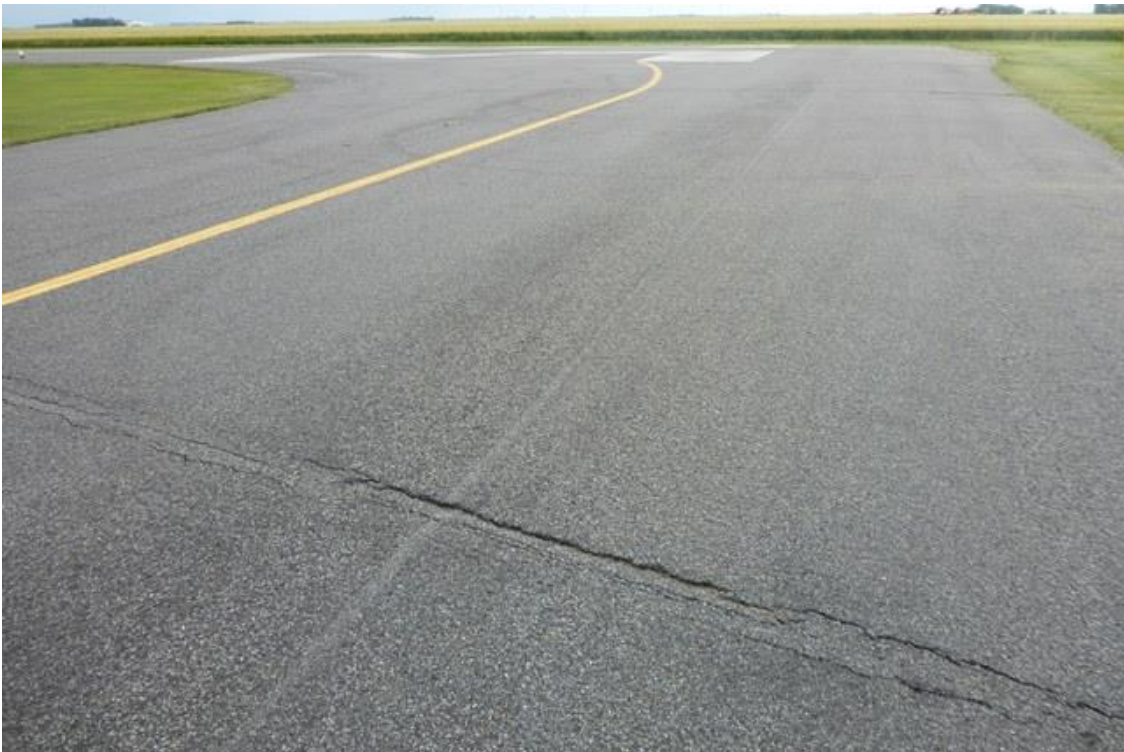
D41 PTA 001 (PCI = 76)

Conditions: PCI: 76

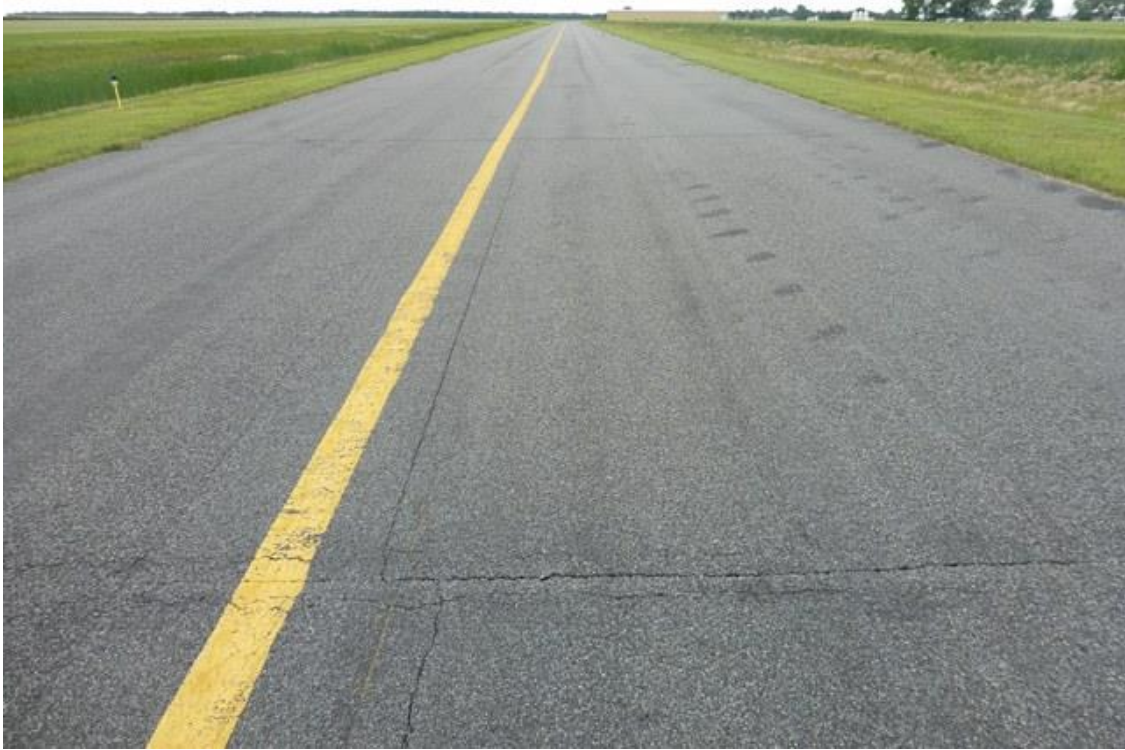
D41 PTA 002 (PCI = 78)

Conditions: PCI: 78

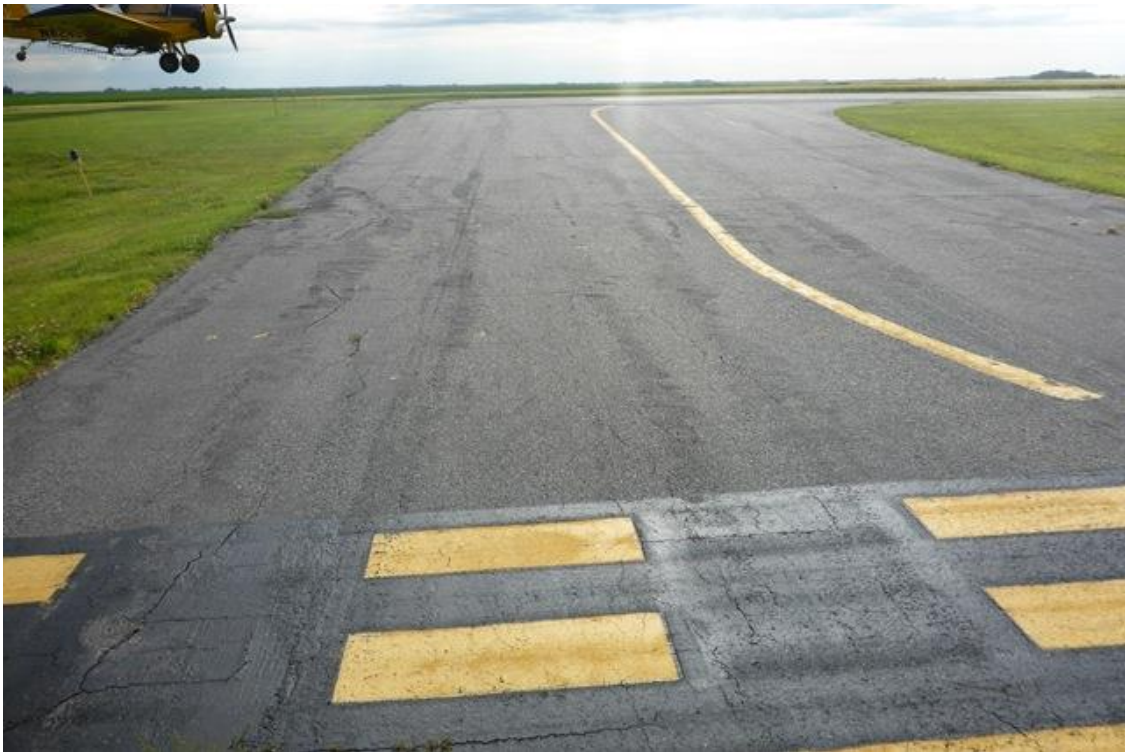
D41 PTA 003 (PCI = 52)

Conditions: PCI: 52

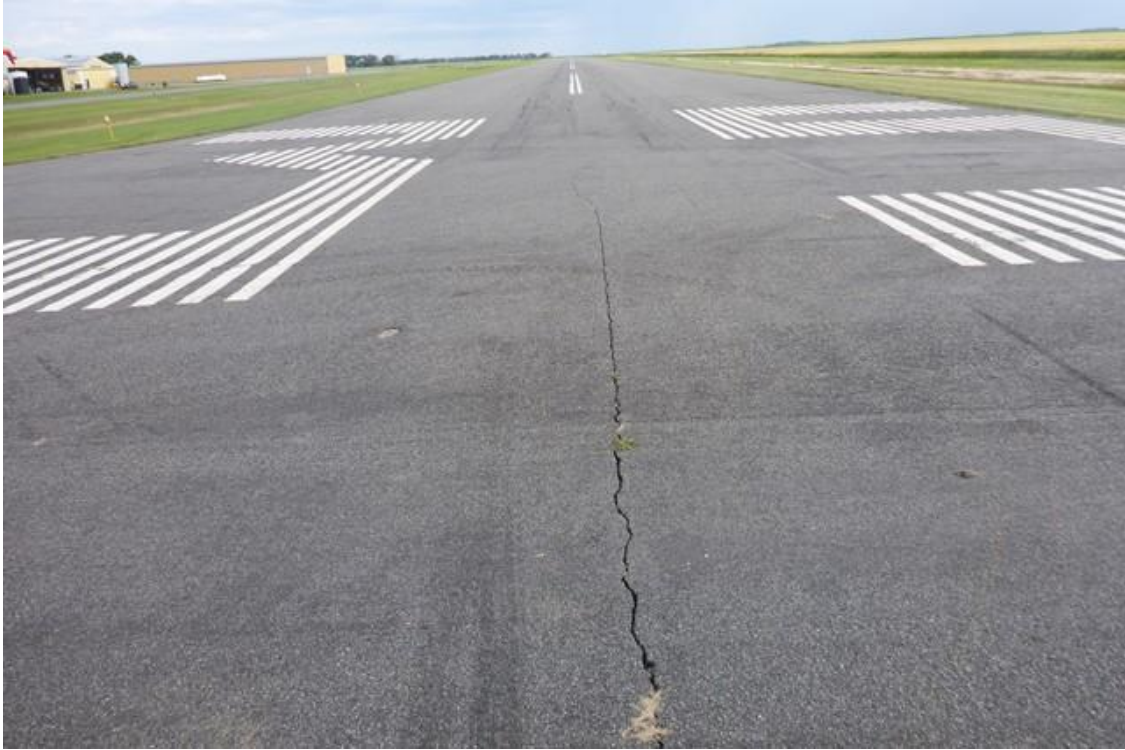
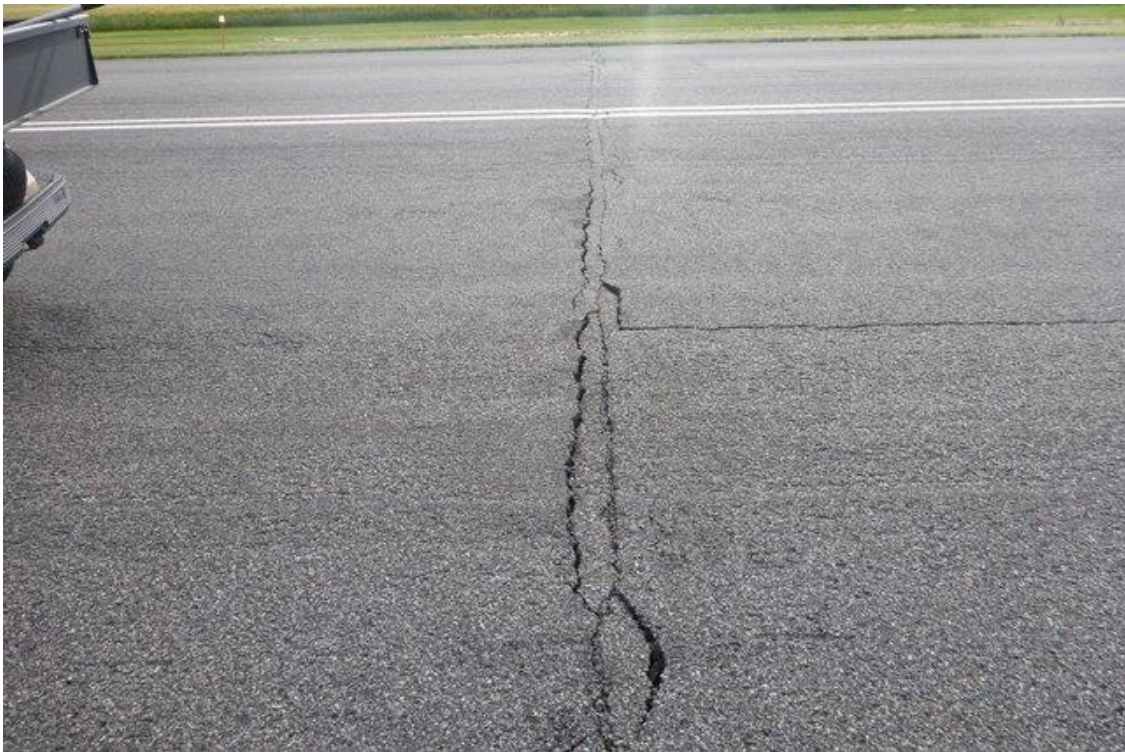
D41 RY1735 001 (PCI = 72)

Conditions: PCI: 72

Inspection Comments: Good Slurry Seal but Crack Seal Not OK

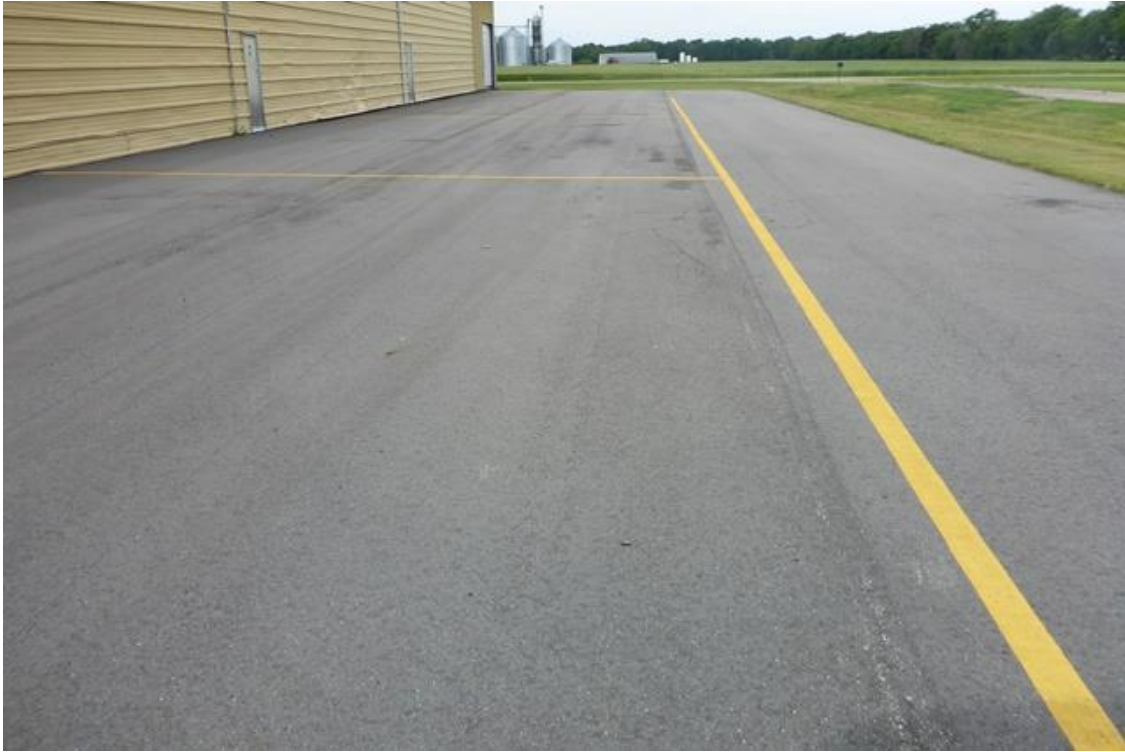
D41 TLA 001 (PCI = 100)

Network:	D41	Name:	STEPHEN						
Branch:	TLA	Name:	TAXILANE A	Use:	TAXILANE	Area:	18,100 SqFt		
Section:	001	of 1	From:	100	To:	104	Last Const.:	9/1/2014	
Surface:	AC	Family:	MN2013 Asphalt Taxilanes	Zone:	N	Category:	3	Rank:	T
Area:	18,100 SqFt	Length:	223 Ft	Width:	145 Ft				
Slabs:		Slab Length:	Ft	Slab Width:	Ft	Joint Length:	Ft		
Shoulder:		Street Type:		Grade:	0	Lanes:	0		
Section Comments:									
Last Insp. Date:	7/16/2016	TotalSamples:	4	Surveyed:	1				
Conditions:	PCI: 100								
Inspection Comments:									
Sample Number:	103	Type:	R	Area:	4000.00 SqFt	PCI:	100
