Pavement Condition Report

Staples Municipal Airport (SAZ)

December 2016

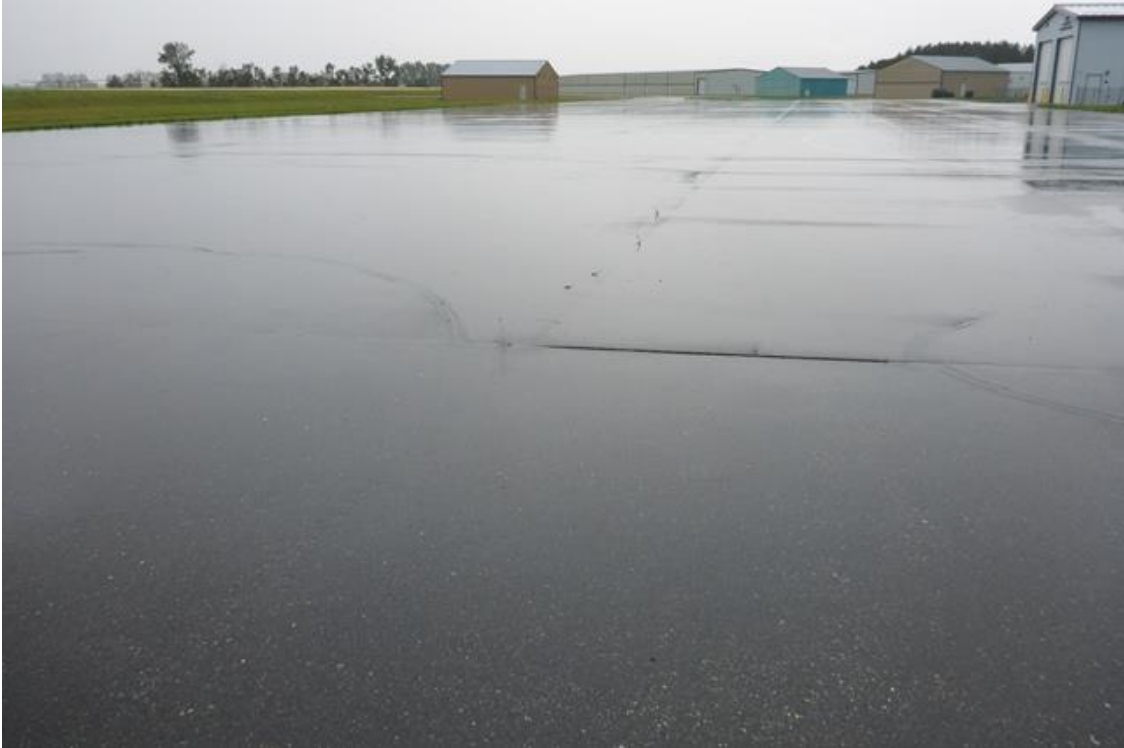
SAZ APA 001 (PCI = 91)

Network:	SAZ	Name:	STAPLES						
Branch:	APA	Name:	APRON A	Use:	APRON	Area:	75,000 SqFt		
Section:	001	of 1	From:	100	To:	304	Last Const.:	6/1/2012	
Surface:	AC	Family:	MN2013 Asphalt Aprons	Zone:	W	Category:	3	Rank:	S
Area:	75,000 SqFt	Length:	500 Ft	Width:	150 Ft				
Slabs:		Slab Length:	Ft	Slab Width:	Ft	Joint Length:	Ft		
Shoulder:		Street Type:		Grade:	0	Lanes:	0		
Section Comments:									
Last Insp. Date:	7/11/2016	TotalSamples:	15	Surveyed:	3				
Conditions:	PCI: 91								
Inspection Comments:									
Sample Number:	103	Type:	R	Area:	5000.00 SqFt	PCI:	89		
Sample Comments:									
48	L & T CR	L	97.00	Ft					
48	L & T CR	M	5.00	Ft					
Sample Number:	202	Type:	R	Area:	5000.00 SqFt	PCI:	92		
Sample Comments:									
48	L & T CR	L	111.00	Ft					
Sample Number:	301	Type:	R	Area:	5000.00 SqFt	PCI:	92		
Sample Comments:									
48	L & T CR	L	119.00	Ft

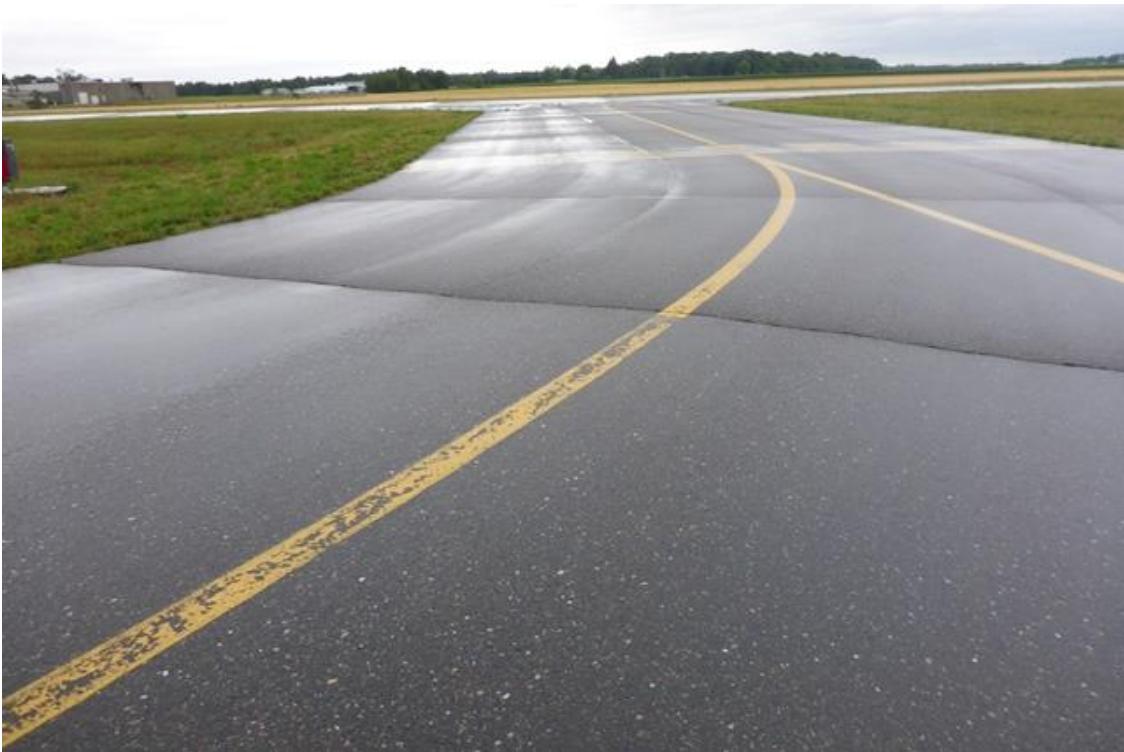
SAZ CTA 001 (PCI = 90)

Conditions: PCI: 90

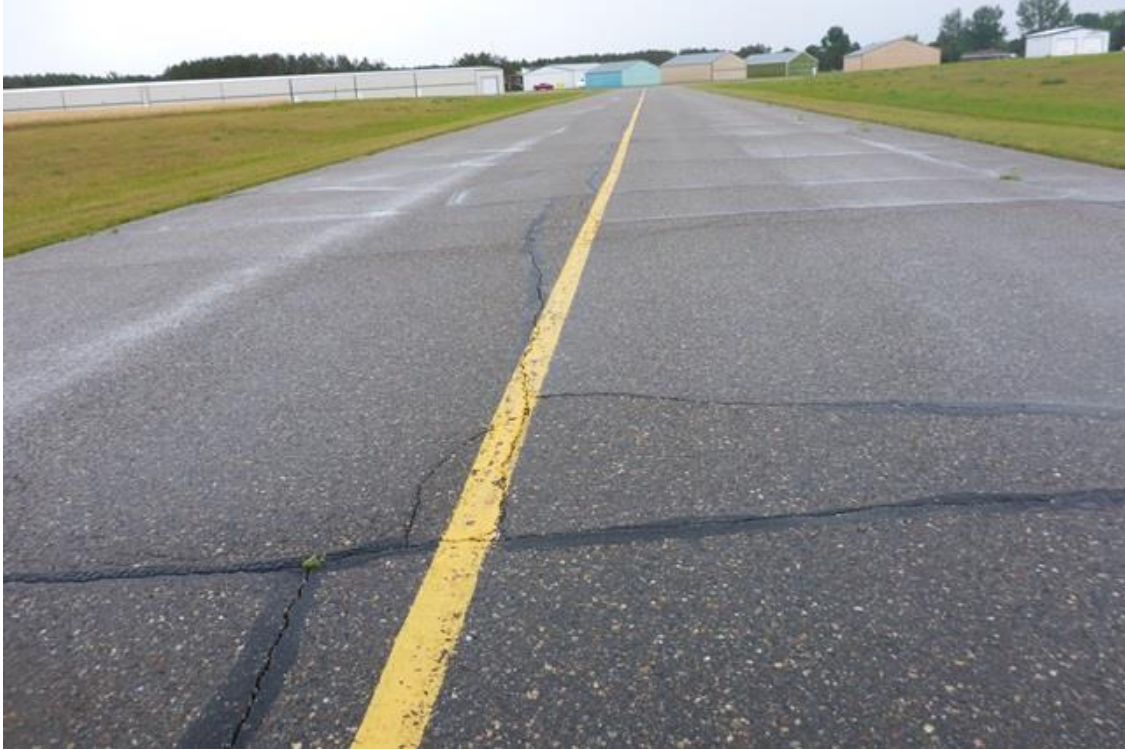
SAZ CTA 002 (PCI = 40)

Conditions: PCI: 40

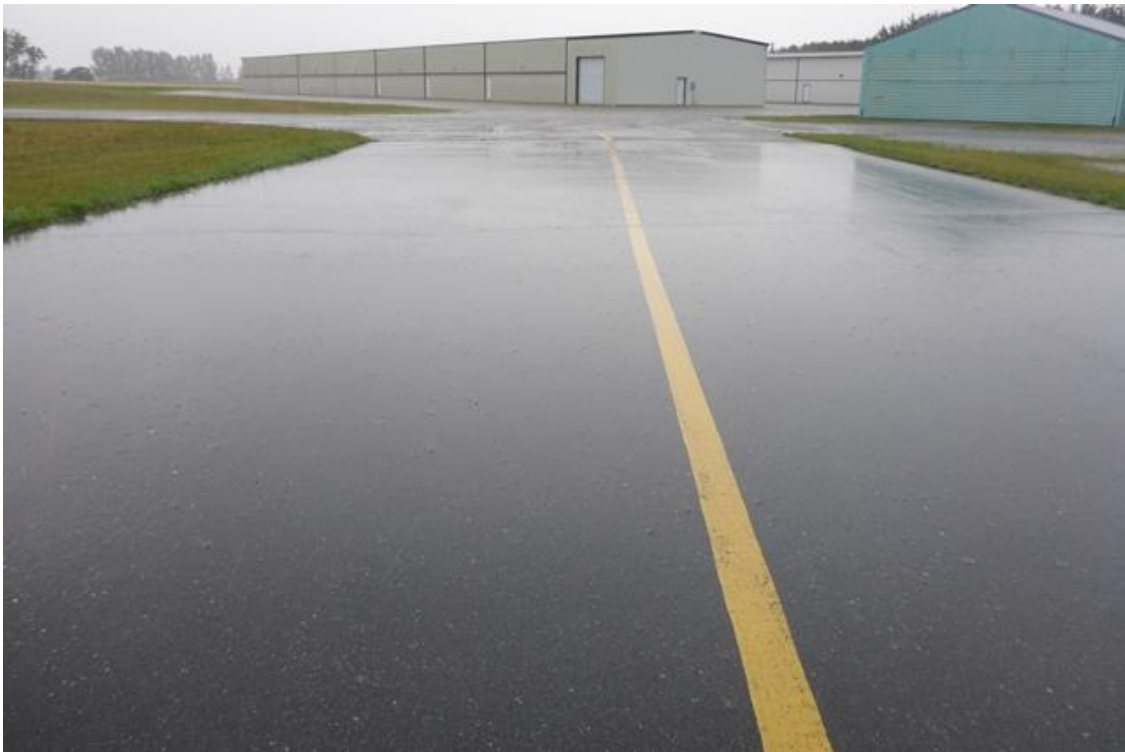
SAZ CTA 003 (PCI = 92)

Network:	SAZ	Name:	STAPLES						
Branch:	CTA	Name:	CONNECTING TAXIWAY A	Use:	TAXIWAY	Area:	48,915 SqFt		
Section:	003	of 3	From:	110	To:	apron	Last Const.:	6/1/2012	
Surface:	AC	Family:	MN2013 Asphalt Taxiways	Zone:	W	Category:	3	Rank:	P
Area:	5,000 SqFt	Length:	120 Ft	Width:	40 Ft				
Slabs:		Slab Length:	Ft	Slab Width:	Ft	Joint Length:	Ft		
Shoulder:		Street Type:		Grade:	0	Lanes:	0		
Section Comments:									
Last Insp. Date:	7/11/2016	TotalSamples:	1	Surveyed:	1				
Conditions:	PCI: 92								
Inspection Comments:									
Sample Number:	111	Type:	R	Area:	4200.00 SqFt	PCI:	92		
Sample Comments:									
48	L & T CR	L	101.00 Ft

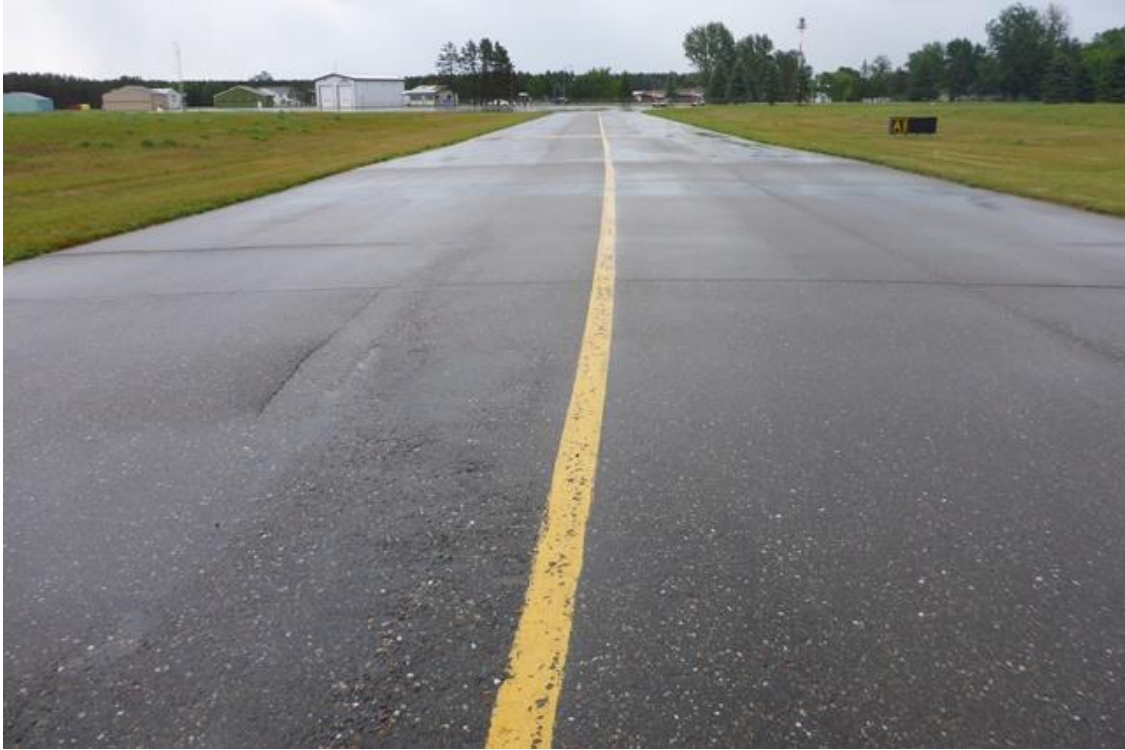
SAZ CTA1 001 (PCI = 84)

Conditions: PCI: 84

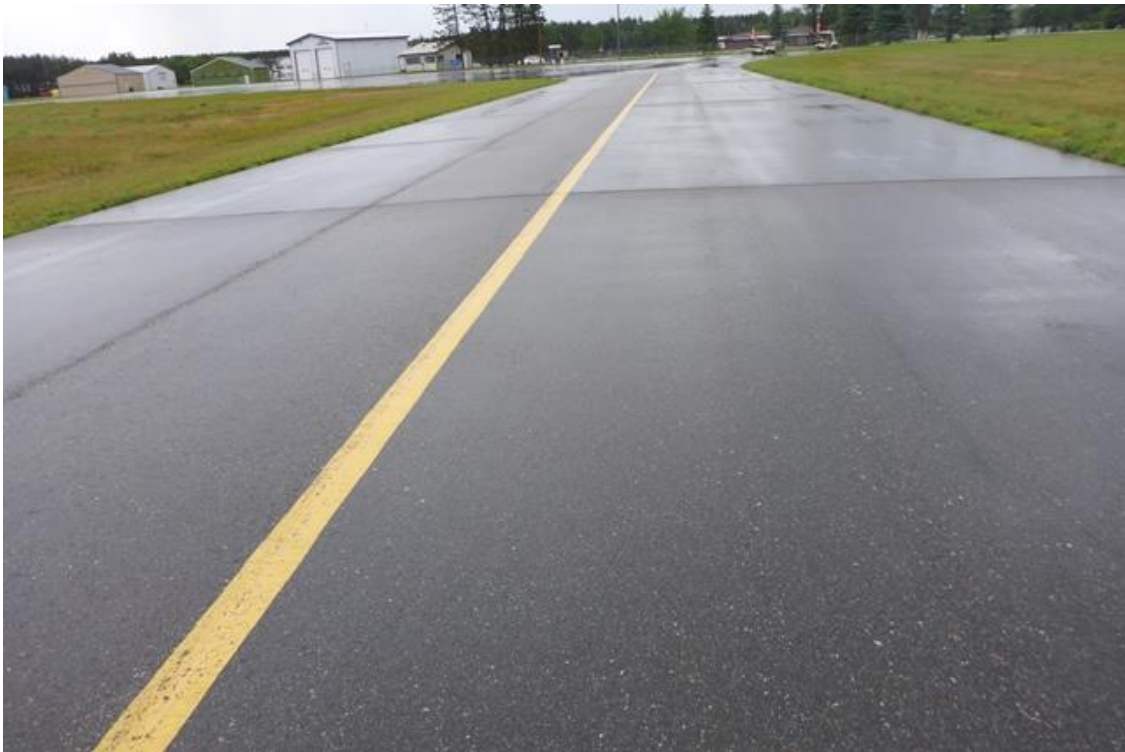
SAZ CTA1 002 (PCI = 92)

Network:	SAZ	Name:	STAPLES						
Branch:	CTA1	Name:	CONNECTING TAXIWAY A1	Use:	TAXIWAY	Area:	17,015 SqFt		
Section:	002	of 2	From:	201+12	To:	203	Last Const.:	6/1/2012	
Surface:	AC	Family:	MN2013 Asphalt Taxiways	Zone:	W	Category:	3	Rank:	P
Area:	12,200 SqFt	Length:	305 Ft	Width:	40 Ft				
Slabs:		Slab Length:	Ft	Slab Width:	Ft	Joint Length:	Ft		
Shoulder:		Street Type:		Grade:	0	Lanes:	0		
Section Comments:									
Last Insp. Date:	7/11/2016	TotalSamples:	4	Surveyed:	1				
Conditions:	PCI: 92								
Inspection Comments:									
Sample Number:	202	Type:	R	Area:	4000.00 SqFt	PCI:	92		
Sample Comments:									
48	L & T CR	L	14.00 Ft						
52	RAVELING	M	5.00 SqFt

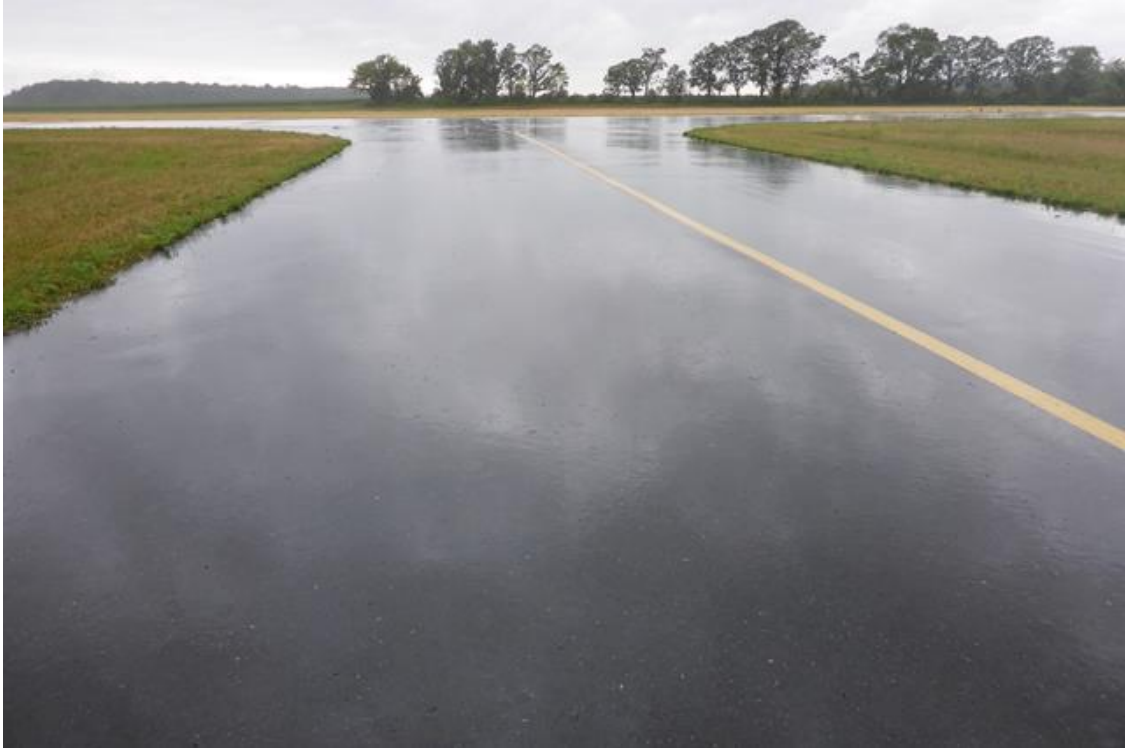
SAZ CTA3 001 (PCI = 100)

Conditions: PCI: 100

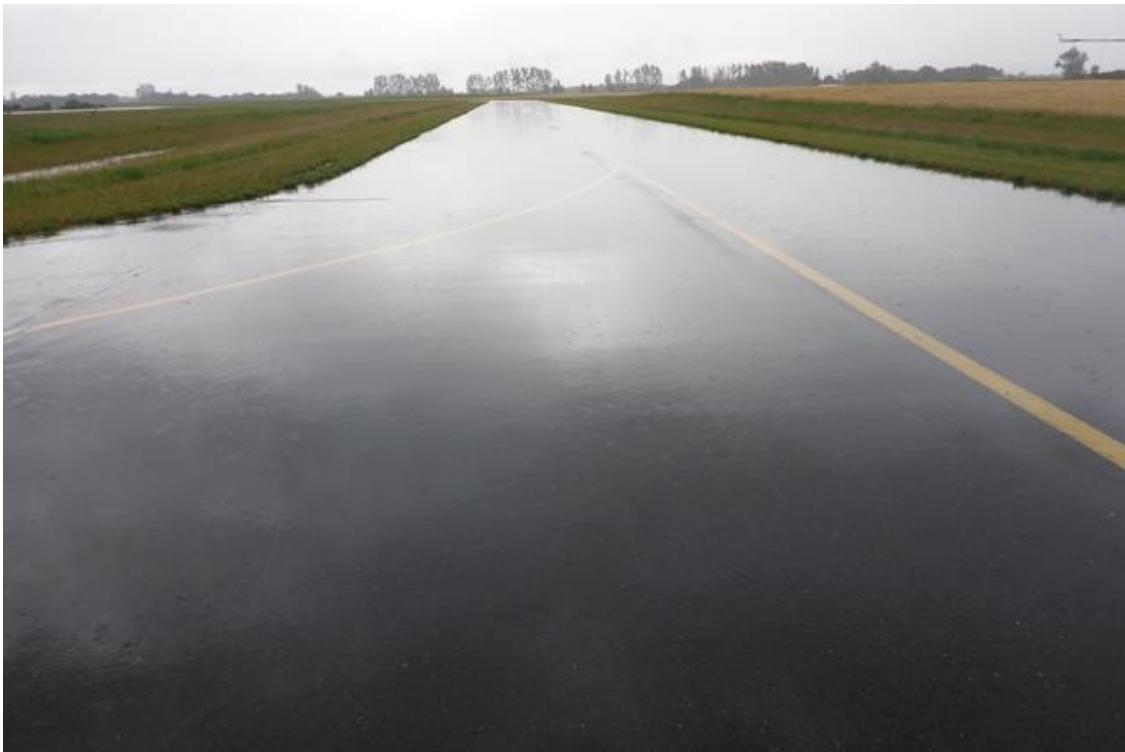
SAZ PPTA 001 (PCI = 100)

Conditions: PCI: 100

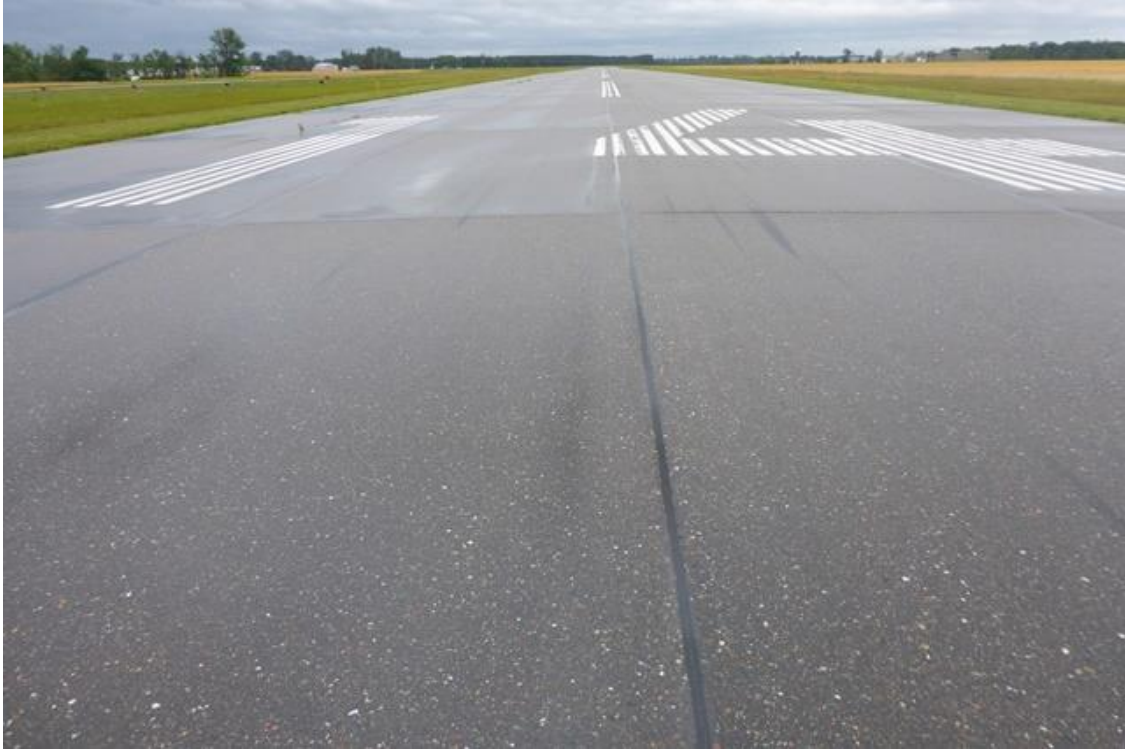
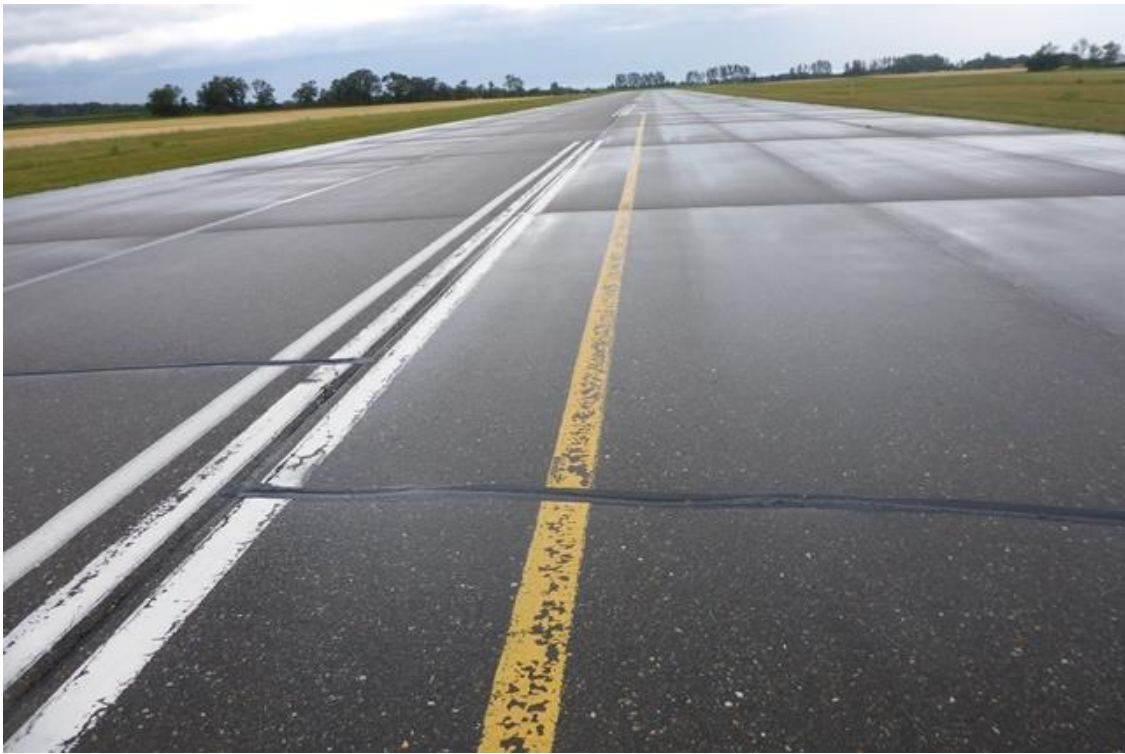
SAZ RY1432 001 (PCI = 79)

Network:	SAZ	Name:	STAPLES						
Branch:	RY1432	Name:	RUNWAY 14-32	Use:	RUNWAY	Area:	247,800 SqFt		
Section:	001	of 1	From:	100	To:	165	Last Const.:	9/1/2006	
Surface:	AAC	Family:	MN2013 Asphalt Runways	Zone:	W	Category:	3	Rank:	P
Area:	247,800 SqFt	Length:	3,304 Ft	Width:	75 Ft				
Slabs:		Slab Length:	Ft	Slab Width:	Ft	Joint Length:	Ft		
Shoulder:		Street Type:		Grade:	0	Lanes:	0		
Section Comments:									
Last Insp. Date:	7/11/2016	TotalSamples:	66	Surveyed:	7				
Conditions:	PCI: 79								
Inspection Comments:									
Sample Number:	103	Type:	R	Area:	3750.00 SqFt	PCI:	75		
Sample Comments:									
48	L & T CR	M	38.00	Ft					
48	L & T CR	L	296.00	Ft					
Sample Number:	113	Type:	R	Area:	3750.00 SqFt	PCI:	76		
Sample Comments:									
48	L & T CR	L	279.00	Ft					
48	L & T CR	M	46.00	Ft					
Sample Number:	123	Type:	R	Area:	3750.00 SqFt	PCI:	83		
Sample Comments:									
48	L & T CR	M	20.00	Ft					
48	L & T CR	L	141.00	Ft

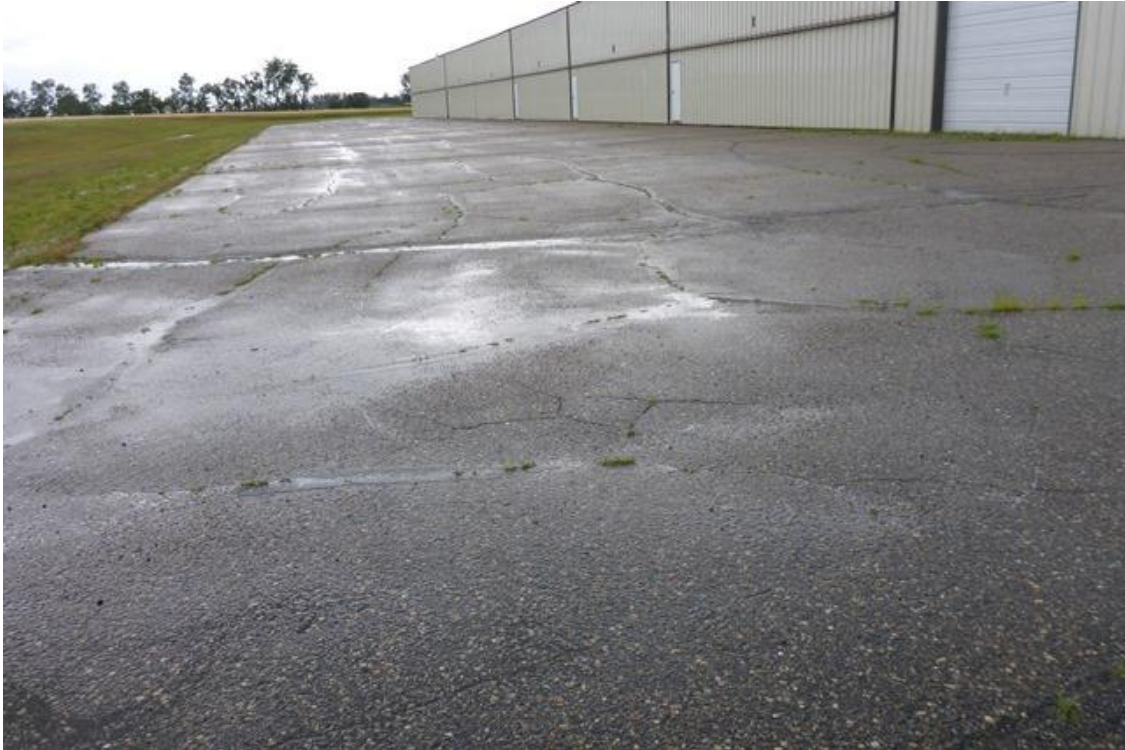
SAZ TLA 001 (PCI = 32)

Conditions: PCI: 32

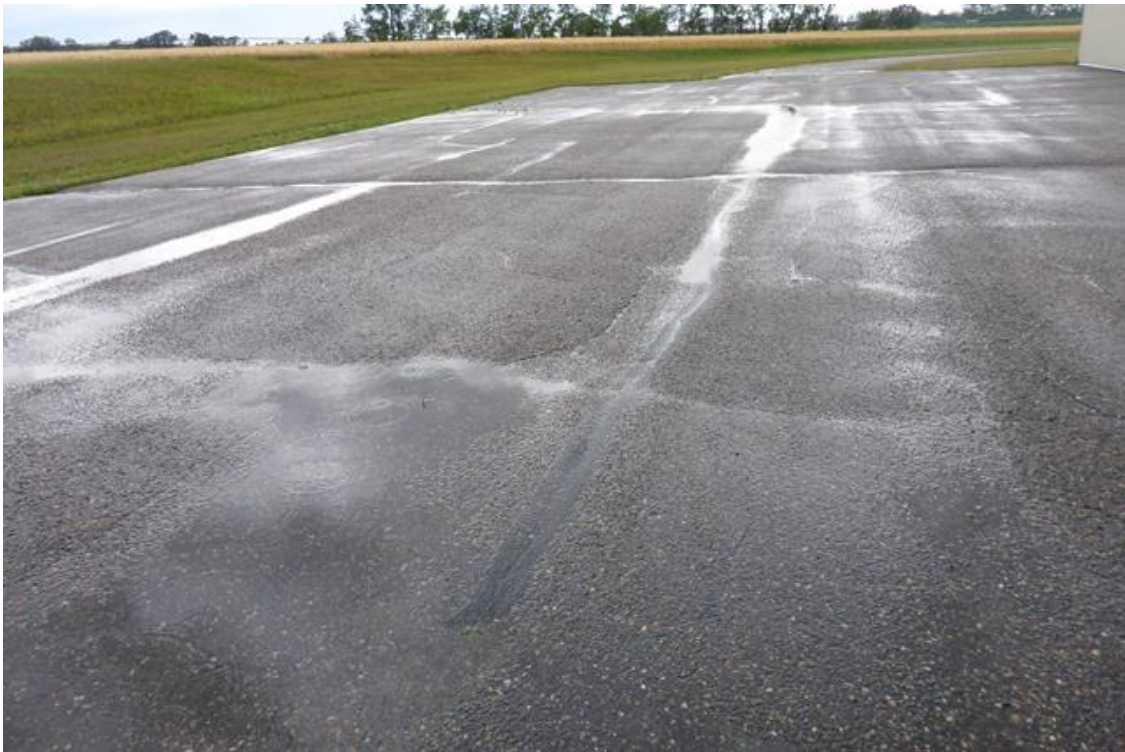
SAZ TLA 002 (PCI = 23)

Conditions: PCI: 23

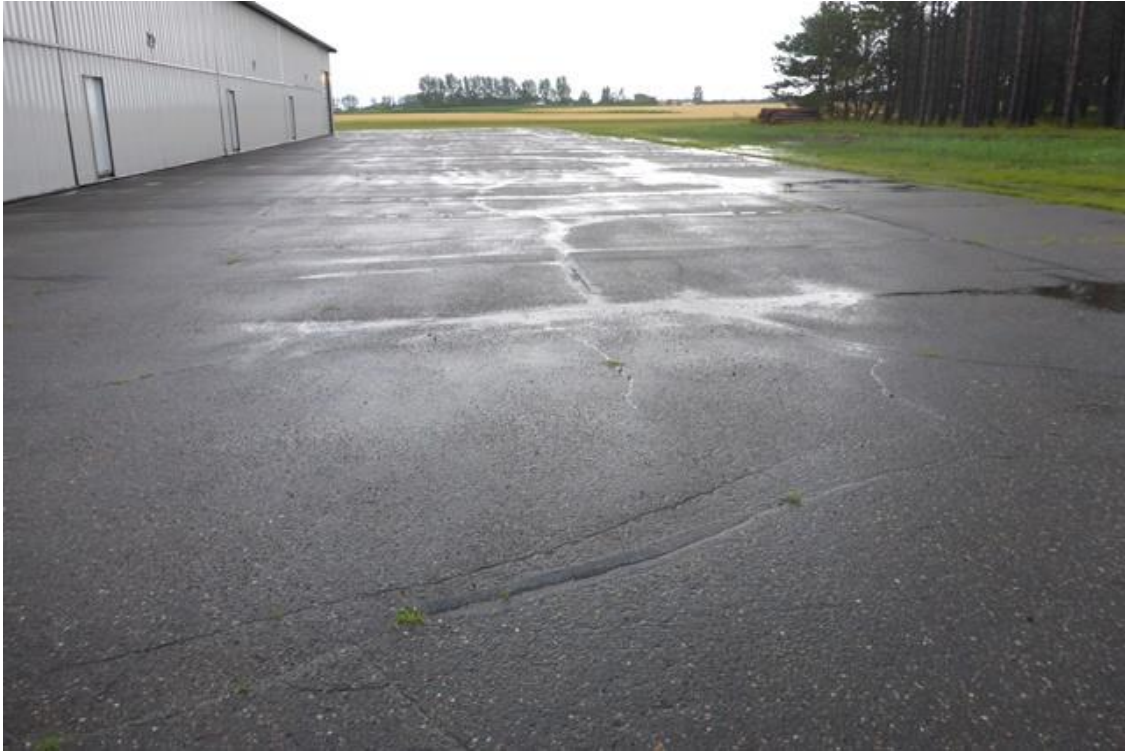
SAZ TLB 001 (PCI = 22)

Conditions: PCI: 22
