WHITEFISH CREEK BRIDGE (BRIDGE 3355)

SHPO INV. # ML-KAN-005

Architect's Survey Date: October 6, 1999

MNDOT HISTORIC ROADSIDE DEVELOPMENT STRUCTURES INVENTORY

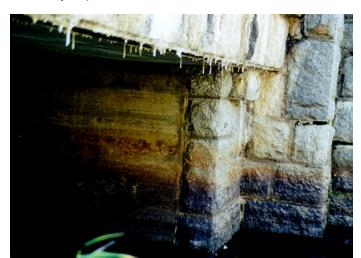
Culvert Condition Showing Granite, Concrete and Water Level Variations
