Pavement Condition Report

Staples Municipal Airport (SAZ)

December 2016

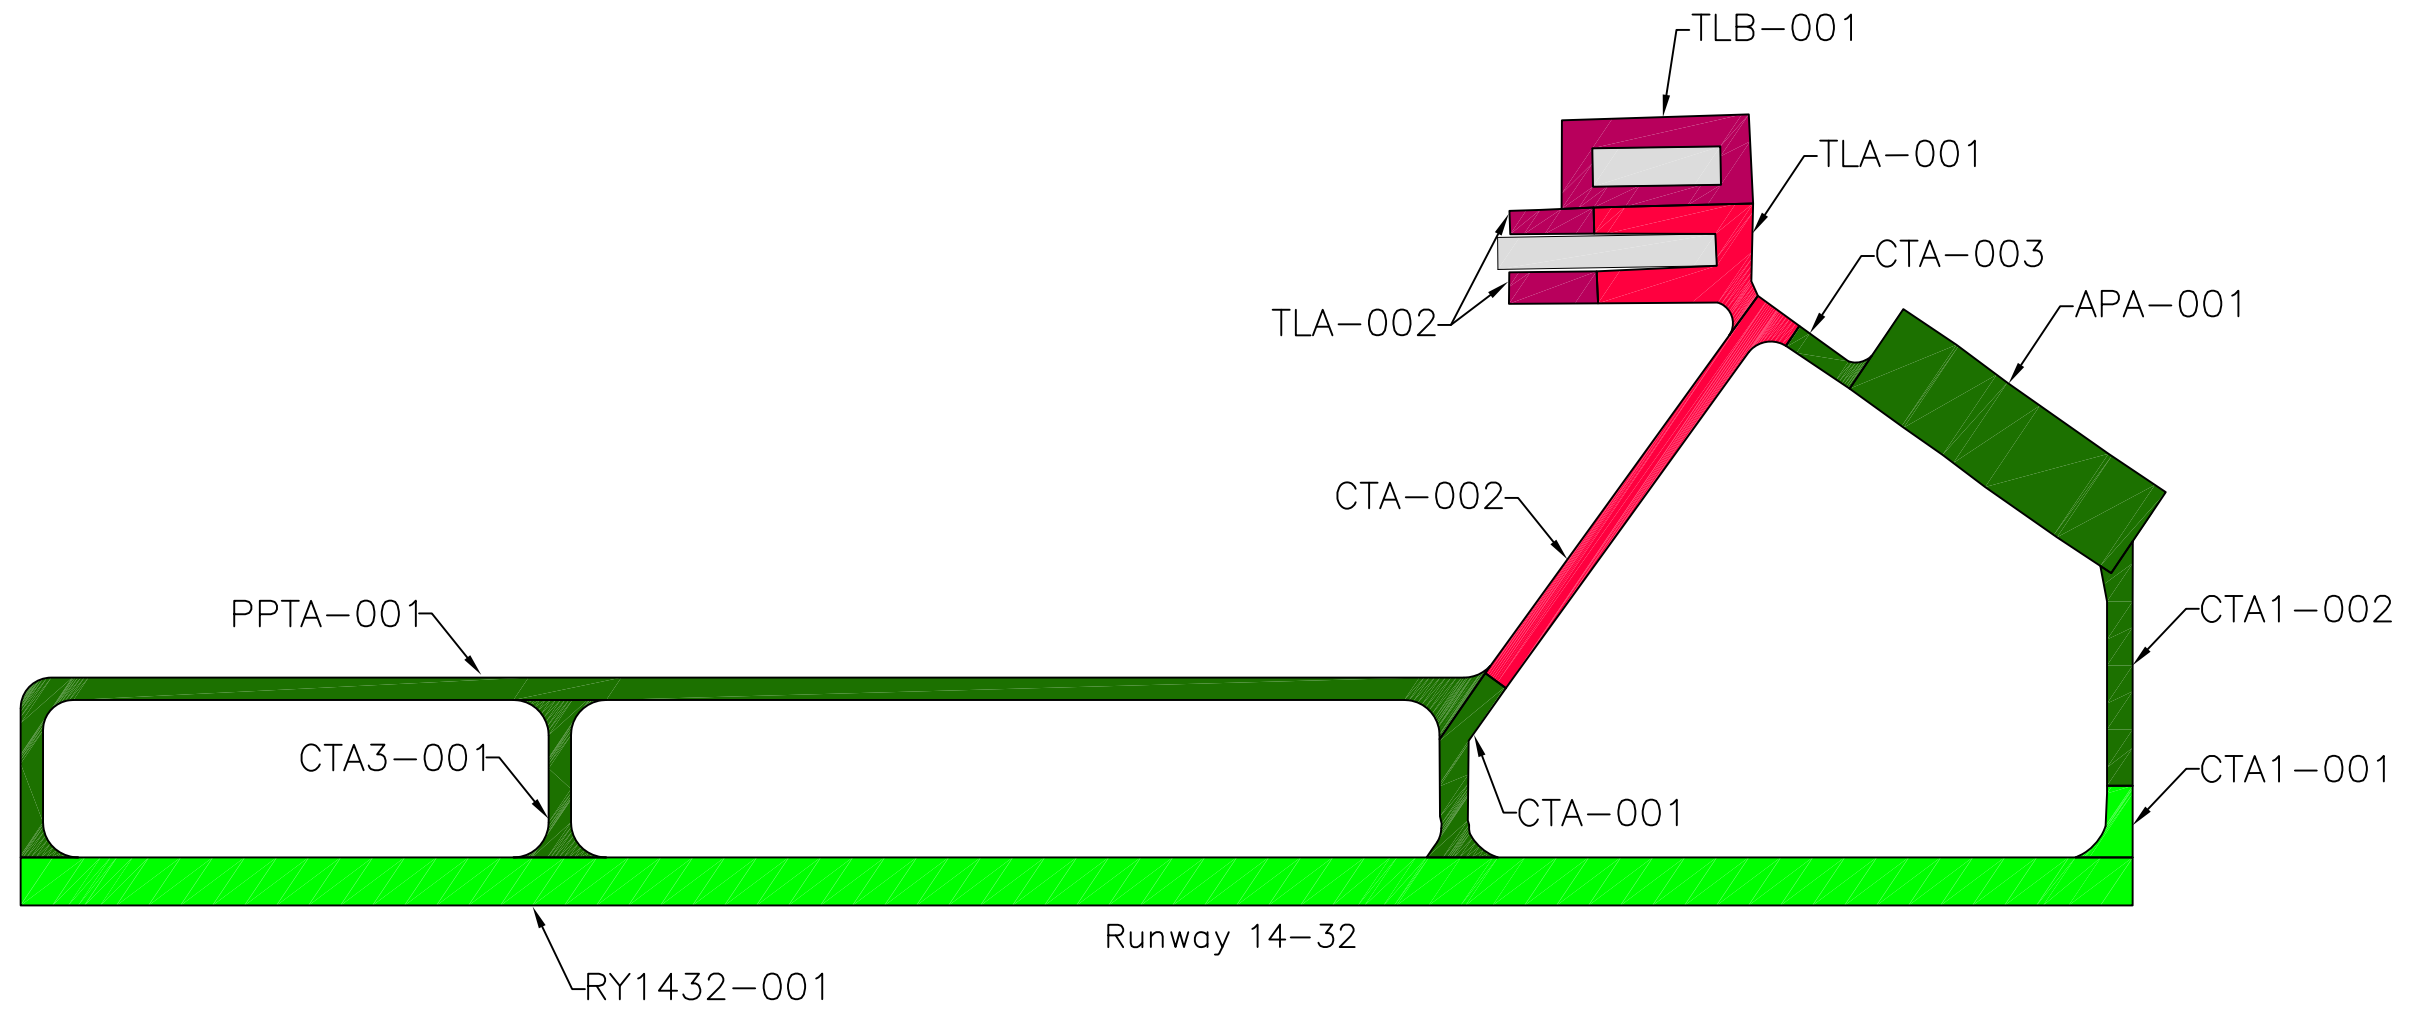
Figure 4. 2016 Pavement Condition Index Rating at Staples Municipal Airport (SAZ).

The results of the 2016 PCI inspection are presented in figure 4. The overall area-weighted, inspected PCI for SAZ is 76. When summarizing PCI values, an area-weighted calculation is used instead of a straight mathematical average because the area-weighted calculations eliminate the skewing of the PCI due to the disparity of the section sizes.
